Structural Testing of 9 m Carbon Fiber Wind Turbine Research Blades

Conference Paper
NREL/CP-500-40985
January 2007

Three 9 m carbon fiber wind turbine blades have been designed through a research program initiated by Sandia National Laboratories. The individual designs feature such innovations as carbon spar caps, material-induced twist-bend coupling, and flatback airfoils, among others. All blades were constructed with conventional dry lay-up and VARTM infusion processes. Static tests of these blades were conducted at the National Wind Technology Center. The blades were subjected to flapwise loading to simulate the extreme wind loads expected for each design in a Class 2b wind site. The blades were loaded with a three-point whiffle-tree arrangement. Upon obtaining the predetermined test load, the blades were subsequently loaded to failure. Load, deflection, strain, and acoustic emissions were monitored throughout the experiments. All blades survived the specified test loads, with two designs exceeding it significantly. In addition, carbon strains of over 0.8% in both tension and compression were recorded in one of the tests. Finally, acoustic microphones were able to detect are

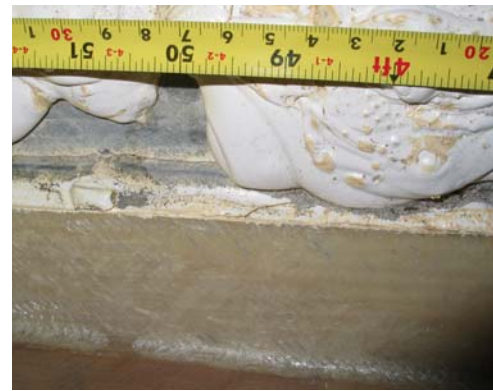
Figure 23: Crack in shear web to LP skin bond joint at 1.20-1.30 m on the CX-100 blade.

During the CX-100 test, several high-energy events were located between 1.20 m and 1.30 m along the spar cap. The CX-100 blade was observed during failure to experience a catastrophic buckling of the low-pressure skin near the 1.2-m station. A post mortem inspection of the blade in this region showed a large crack in the bond joint between the low pressure skin and the shear web. A photograph of the crack is shown in Figure 23.

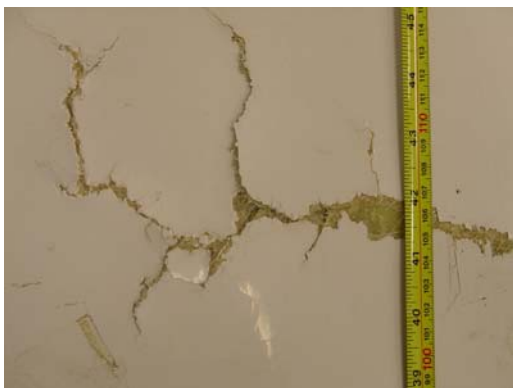
Figure 24: Crack near blade centerline on TX-100 blade.

The TX-100 blade test produced high-energy events just beyond the 1.00 m station. The blade eventually failed at the 1.0-m station, with a failure described as a buckling of the compressive skin, initiated towards the leading edge. A photograph of the fracture is shown in Figure 24.

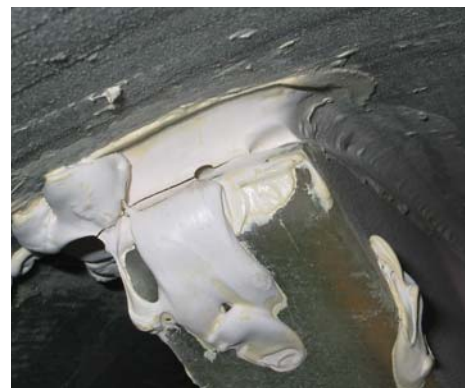
Figure 25: Crack at shear web termination on the LP surface of the BSDS blade.

During the BSDS test, the only high-energy events were located around 0.350 m, which the station where the shear web terminates on the root end. A closer examination of this area after the test showed that a large crack had developed between the low-pressure skin and the shear web in the bonding joint. A photograph of the crack is shown in Figure 25.
